TECHNICAL INFORMATION

Product Name Nikon FM2/FE2/FA

Ref. No. FM2-840024

SHUTTER IMPROVEMENTS

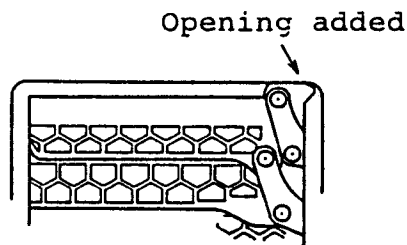
Figure 1

The upper wind-side corner of the inner aperture frame has been re-contoured to prevent the interference with the edge of closing curtain that travels with shaking between the aperture frames. See Figure 1.

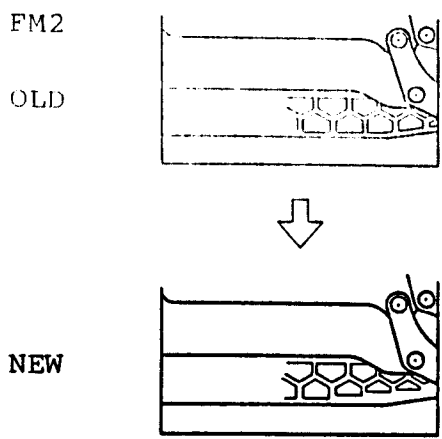
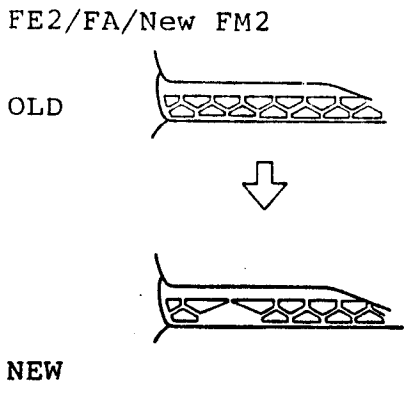
One part of the honeycomb structure has been changed to reinforce the blade of closing curtain. See Figures 2 and 3.

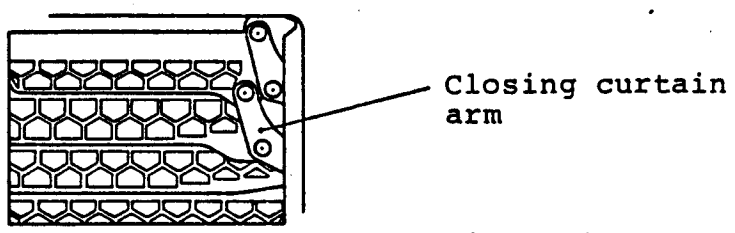
Figure 4

The material of closing curtain arm has been changed from titanium into carbon steel for reinforcement. See Figure 4.

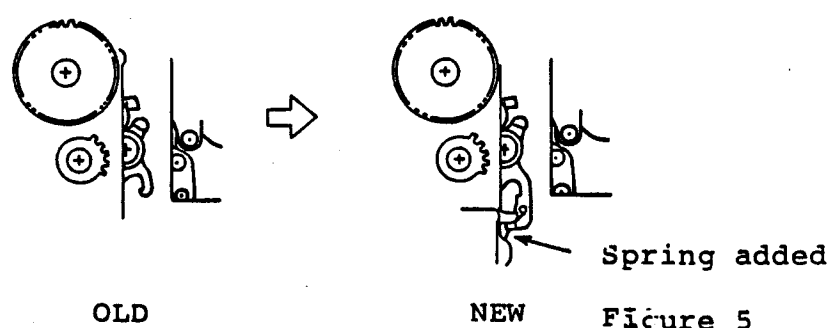
Figure 5

A spring has been added to the closing curtain brake to increase the efficiency of braking. But this has not been applied to the former FM2 camera. See Figure 5.

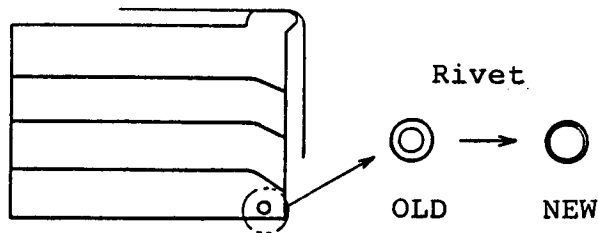
Figure 6

The rivets have been modified to prevent dislocation of shutter curtain blades. See Figure 6.

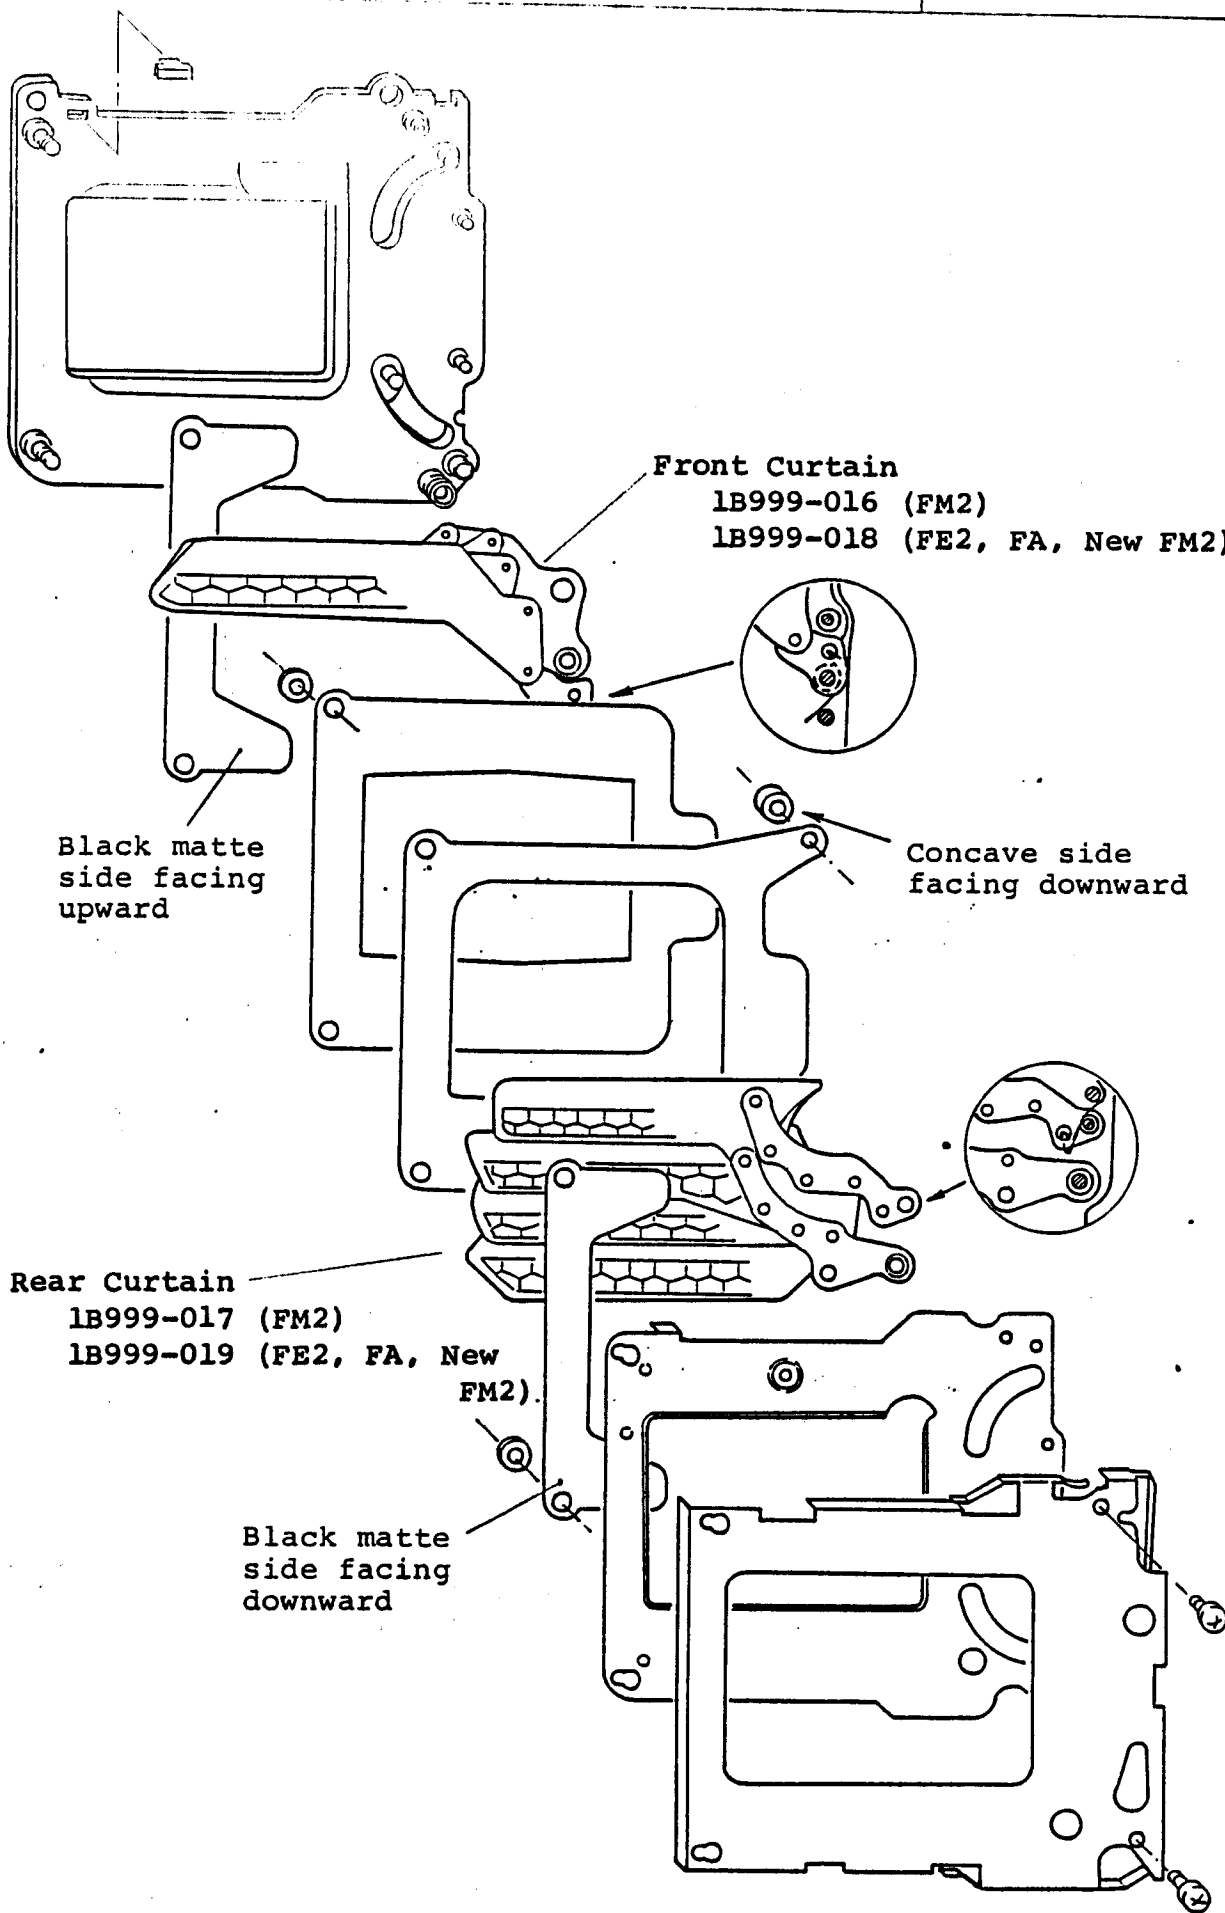
Front Curtain
1B999-016 (FM2)
1B999-018 (FE2, FA, New FM2)

Black matte
side facing
upward

Concave side
facing
downward

Rear Curtain
1B999-017 (FM2)
1B999-019 (FE2, FA, New
FM2)

Black matte
side facing
downward

1. Check if the spare curtain blade is precisely flat, before installing.
2. See the illustration attached to disassemble/reassemble the shutter unit. The parts illustrated are of improvements. If a different pre-improved part is found in the unit of previous FM2 camera, it should be replaced in addition to the spare curtain blades. A junk shutter unit available should be disassembled to obtain the parts in need.
3. After reassembling, install the shutter unit in the camera body temporarily to check the shutter speed delivery. Set M250 when checking the FE2 and FA cameras.
